U. S. Department
of Transportation
**Maritime
Administration**

Port Damage Assessment

Short-term Action Report—April 2000

**Honduras: Assessment of Port Infrastructure
Damage Caused by Hurricane Mitch, 1998**

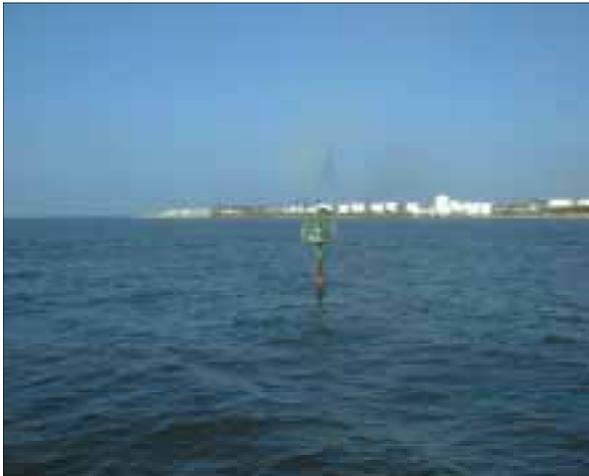
Photo 1. *No. 3 Entrance Channel Marker*

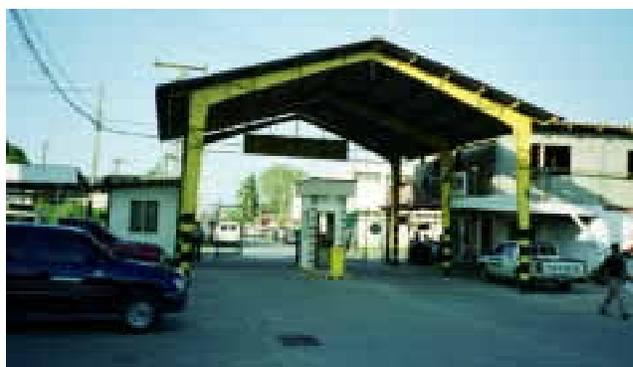
Security Force Issues: Puerto Cortés had two levels of security forces. ENP personnel patrol the gates and open areas, while the private leaseholders employ their own guards within their leased areas inside of the port’s main security fence. ENP guards lacked identification, proper uniforms, and weapons. In addition, they did not have adequate communications equipment or vehicles. The private guards for the leaseholders were generally better equipped than the ENP guards but were still below standard. Poor communication seems to exist between the ENP and port users, as well as between the ENP guards and the private guards. In some cases an atmosphere of mistrust seemed to exist between the two groups of security.

Photo 4. Entrance gate near Administration Buildings

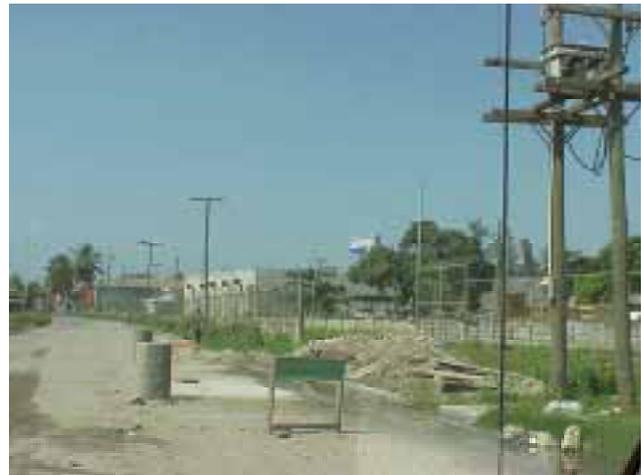
Equipment Issues: The perimeter security fence has several damaged areas and some areas where the fence is below standard height. Because the port is situated directly adjacent to the city of Cortés, open space zones are virtually eliminated, which exacerbates the fence vulnerability. Also, some buildings outside the port adjoin the perimeter fence, making illegal access easier. Currently, no remote systems (e.g., cameras and motion sensors) have been installed to assist the guards. The truck entrance gate is generally secure; however, the entrance near the administration buildings is poorly guarded, and unauthorized people were seen entering the port at this gate.

Photo 5. *Railroad gate in Security Fence Left Open and Unattended*

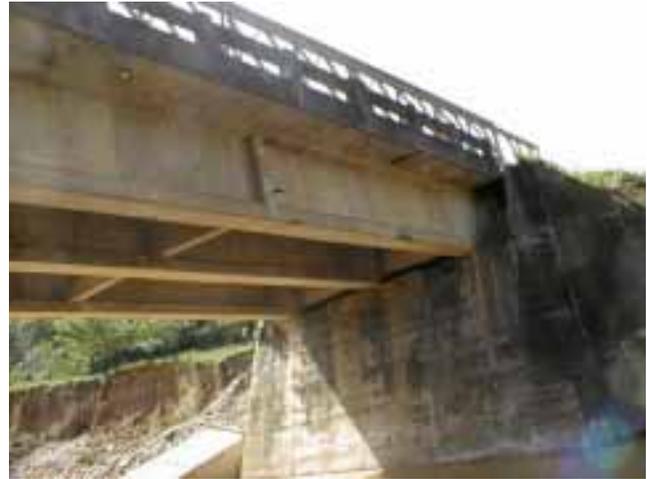
1. Bridge over Rio Silin (N15.93100, W085.89073). The north abutment failed because of scour (see Photo 6). A temporary bridge was installed but the structure failed in subsequent heavy rains. The Team recommends that the existing bridge be replaced with a longer single-span structure. The estimated cost is \$409,000 (U.S.). This project is not included in any proposed repairs (priority 1).

Photo 6. Bridge with North Abutment Failure

1. Rio Silin Bridge—North abutment failed; recommend replacement with a longer single span structure	\$409,000
2. CREM Culvert—Washed out culvert; construction of double 3x2 box culvert planned; also recommend slope protection and sound hydraulic study	\$51,000 (study and slope protection)

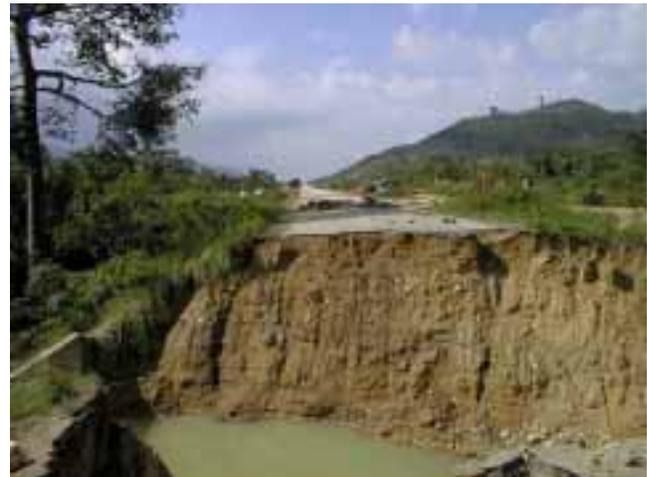
2. Culvert washed out in front of CREM (N15.91071, W085.85396) (see Photo 7). Damage was caused by additional heavy rains. Existing plans call for the construction of a double 3 x 2 foot box culvert. In addition to the planned work, the team recommends that the fill slopes be protected from erosion and the outlet be protected from scour. The proposed work is acceptable provided that it is validated by a sound hydraulic study. The estimated additional cost of the study and slope protection is \$51,000 (U.S.) (priority 1).

Photo 7. Culvert Washed Out

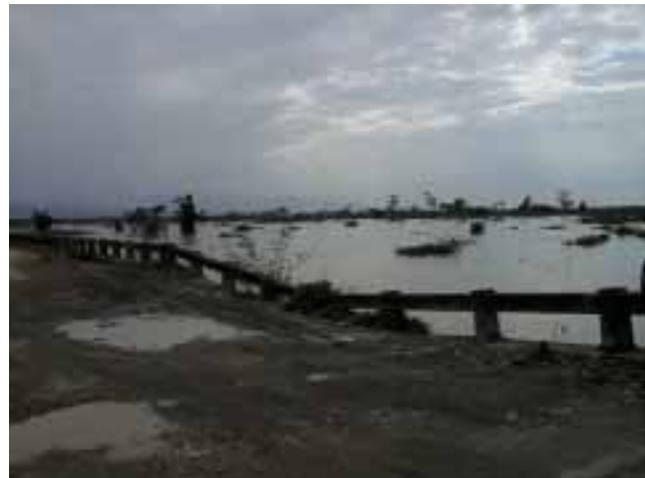
4. Relief Bridge for Rio Aguan #9 (N15.84258, W085.79709). The roadway was totally washed out for a length of 1 kilometer (see Photo 8). Some slope protection is underway under an existing reconstruction project at some locations. The team recommends slope protection for the entire section, especially downstream of the floodplain. The estimated cost is \$136,000 (U.S.).

Photo 8. Existing Bridge also Requires Relief Bridges to Avoid Future Flood Damage

A stream geomorphology study should be conducted to evaluate any change in river patterns, dimensions, or orientation because of Hurricane Mitch floods. This study is required to locate the proposed relief structures. The team recommends the construction of new relief bridges (bridges are required to prevent the trapping of debris upstream) as determined by the above the study. Assuming that two new relief structures are required, the estimated cost of the new bridges and the road reconstruction is \$817,000 (U.S.) (the road reconstruction is included in the existing contract but the cost of the new relief bridges, \$681,000 [U.S.], is not). The team also recommends repairs to the bridge approach embankment of the existing bridge at an estimated cost of \$34,000 (U.S.). Roadway and bridge reconstruction are ranked priority 1; the geomorphology study and new relief bridges are priority 2.

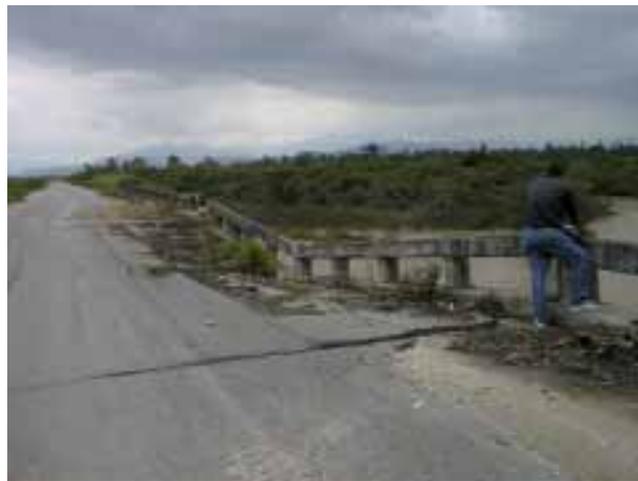
5. Relief Bridge #8, Rio Aguan. (N15.83306, W085.79116). Two piers collapsed affecting four spans (see Photo 9). The bridge length is approximately 100 meters. The team recommends that the entire bridge be replaced at a cost of \$1.362 million (U.S.). This project is included in a future World Bank project (priority 2).

Photo 9. *Damage Caused by Collapsing Piers*

Project Area/Project Description	Cost (U.S. dollars)
5. Relief Bridge #8 Rio Aguan—Two piers collapsed affecting four spans—bridge length 100 meters; recommend entire bridge be replaced	\$1,362,000

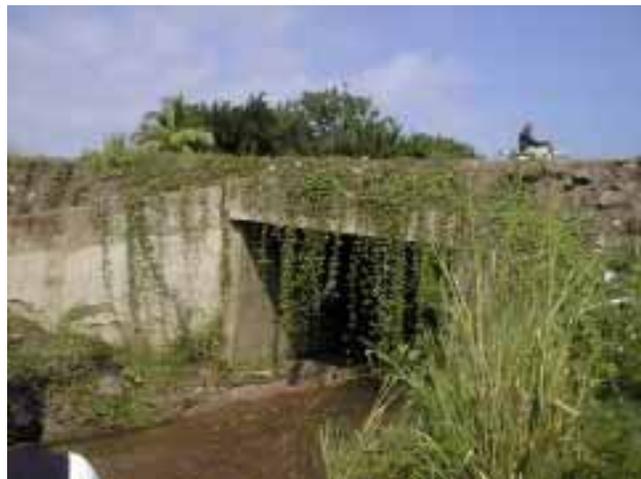
10. La Colorada, Sector Guaimitos, CA13 between Progreso and Tela (N15.50330, W87.69947). Hurricane Mitch created a new flow, joining the existing flow at the structure (see Photo 10). The embankment was washed out and has since been repaired. However, there is damage to the frame as a result of recent settlement. The team recommends a new 20-meter bridge with 50 meters of road reconstruction at a cost of \$272,000 (U.S.) (priority 1).

Photo 10. *Embankment Washed Out*

9. Embankment washed out; recommend that a new relief bridge replace 2-feet x 6-inch culverts	\$218,000
10. CA13—Damage to frame as a result of settlement; recommend 20 meter bridge and 50 meter road	\$272,000

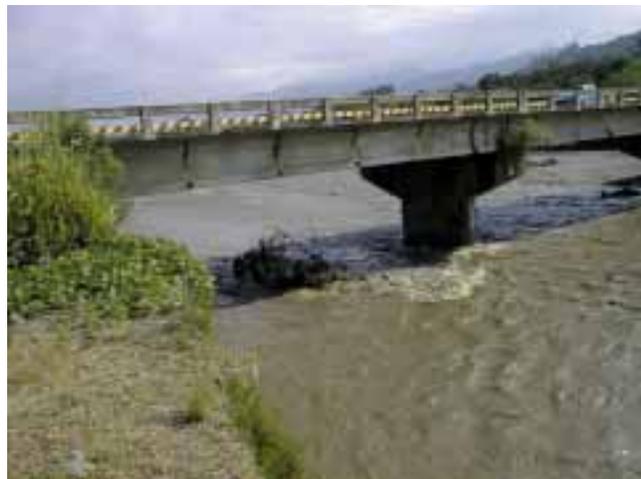
11. Bridge over the Rio Guaymon (N15.51423, W87.66821). The bridge is 125 meters long. Two piers settled, one about 0.5 meters (see Photo 11). The beams were raised and temporary concrete blocks were installed. To reduce the future risks, the team recommends that the structure be replaced at an estimated cost of \$1.022 million (U.S.). A possible lower cost alternative would be to study the extent of damage and design a retrofit if the damage is not extensive (priority 1).

Photo 11. *Piers Settled, Bridge Supported by Temporary Concrete Block Between Pier and Deck*

11. Rio Guaymon Bridge —125-meter bridge; recommend structure replacement (a possible lower cost alternative would be to conduct a study of the amount of damage and design a retrofit if the damage is not extensive)	\$1,022,000

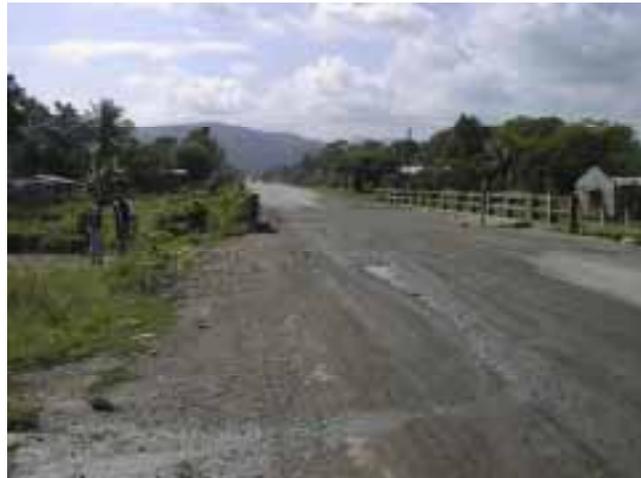
12. Pavement damage over bridge at Toyos Sector (N15.54116, W84.65208). Pavement damaged as a result of flooding above the bridge (see Photo 12). The team recommends that a wall be constructed in front of the open abutment and bank protection be provided on the area of the north abutment (#2) at an estimated cost of \$20,000 (U.S.) (priority 2).

Photo 12. Road Damaged by River Overflow

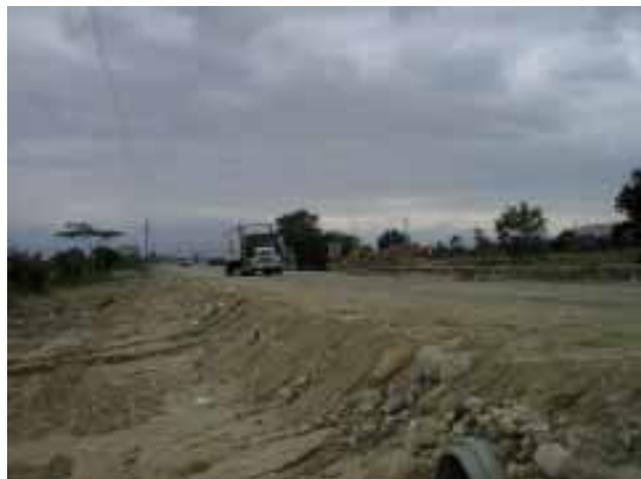
13. Rio Leon Area (milepost kilometer 117) (N15.66779, W87.33512) between Tela and La Ceiba. Water topped the highway damaging the embankment and the pavement for about 300 meters (see Photo 13). Under an existing contract, reinforced concrete pipes are being installed and the embankment is being restored. This is the continuation of an existing relief structure that suffered minor damage during Hurricane Mitch. The team recommends that, for maintenance purposes, a minimum pipe diameter of 30 inches be used on culverts crossing the main road. The team also recommends flare-end sections at the inlet to improve the capacity of the culvert.

Photo 13. Large Culverts Needed

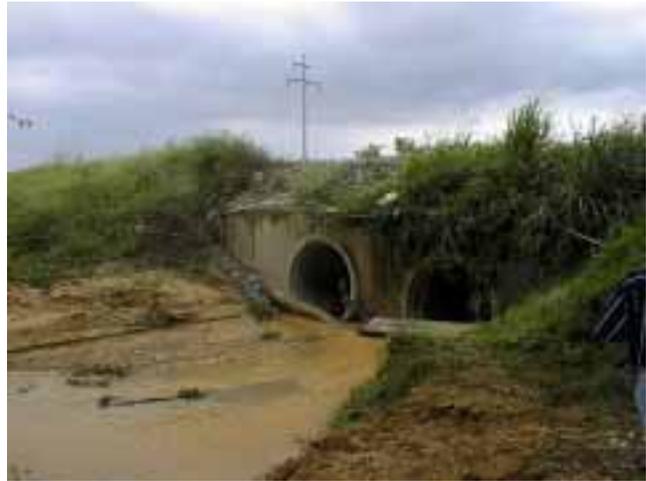
15. Roadway, embankment, and culverts washed out (see Photo 14). (N15.61645, W87.12403.) Under existing contract, a new 2x48-inch reinforced concrete pipe culvert has been installed and the embankment restored. The team also recommends that to improve the inlet and protect the channel banks, the inlet channel be re-aligned and the culvert and the embankment slopes be protected near the culvert. The estimated cost is \$10,000 (U.S.) (priority 2).

Photo 14. *Inlet Channel Needs Re-Alignment with Culverts*

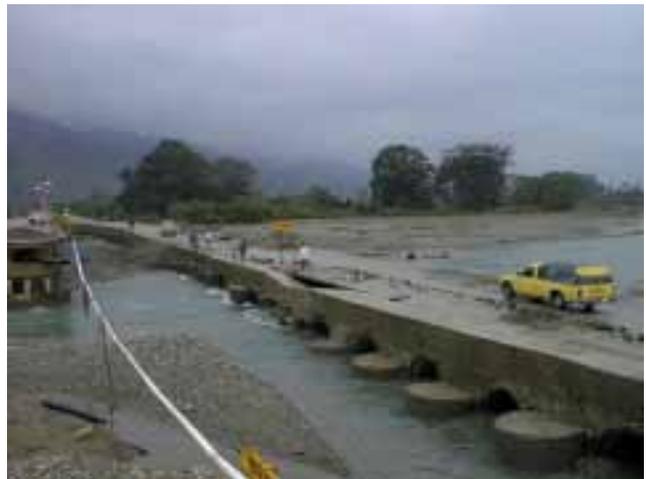
16. Bridge over the Rio Perla (N15.69310, W86.98139) was severely damaged (see Photo 15). The government of Sweden is funding a new bridge. Studies and design are underway. A temporary crossing built by the U.S. Army was damaged in recent heavy rains.

Photo 15. *Both Permanent and Temporary Bridges Damaged*

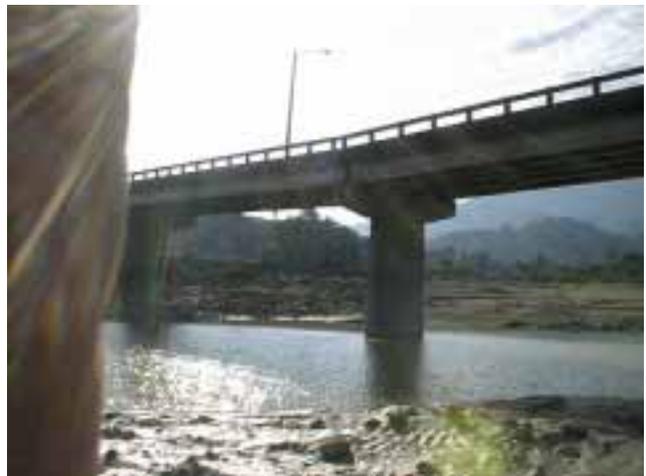
18. Bridge over the Rio Danto has scour problems (see Photo 16). This bridge is the only access to La Ceiba. Further studies are required to determine the amount of damage (priority 2).

Photo 16. *Scour Problems and Pier Settlement*

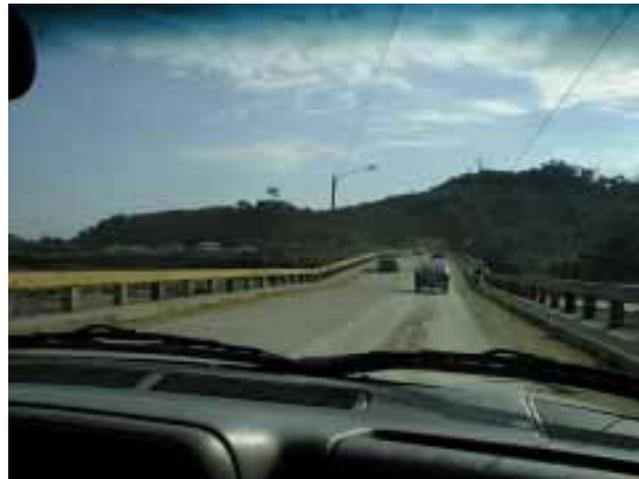
19. Bridge Saopin over the Rio Cangrejal (N15.76260, W86.78388). A nine-span bridge that is about 270 meters long suffered major damage during Hurricane Mitch (see Photo 17). The south abutment #1 was destroyed and one of the piers is settling. A new bridge will be designed and built by the Swedish government. Both this bridge and the previous one over the Rio Danto are essential in connecting La Ceiba with the rest of the country.

Photo 17. Pier Settlement Causes Road to Buckle

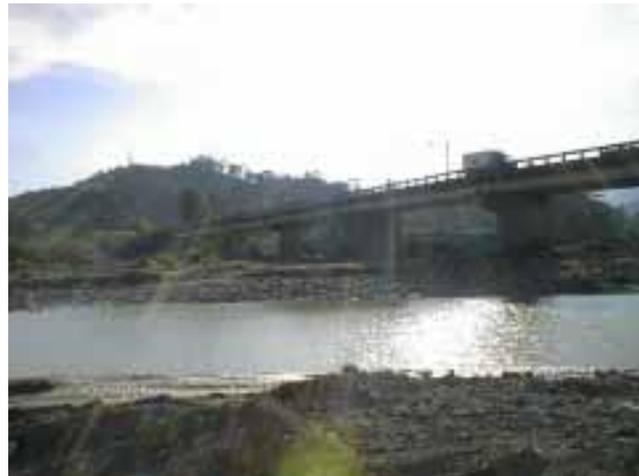
20. El Aire Sector (N15.70293, W86.50286) corrugated metal pipe washed out (see Photo 18). A temporary bridge was constructed. The consultant on the project is proposing the construction of a 3x72-inch concrete-pipe culvert. This project is included in the ongoing World Bank contract. The design of the culvert should be validated by a hydraulic study.

Photo 18. Hydraulic Study Needed

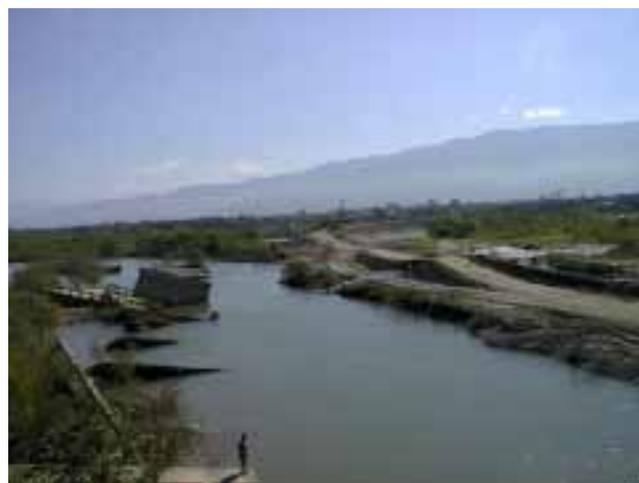
21. Roadway completely washed out (N15.54406, W86.24429) at Saba (see Photo 19). Apparently, the water level peaked at 3 meters above roadway elevation. Roadway length to the first relief bridge is 2.5 kilometers. The Swedish government will re-align the road and construct new bridges. The first relief bridge (N15.53119, W86.23561) with 12 spans, each 12 meters long, was totally destroyed. The Swedish government is building this project. Main bridge over Rio Aguan was destroyed by

Photo 19. Both Permanent and Temporary Bridges Destroyed

Hurricane Mitch. A temporary bridge is under construction. (The team could no longer continue on the route, and detoured using a parallel dirt route that was approximately 30 kilometers to the east).

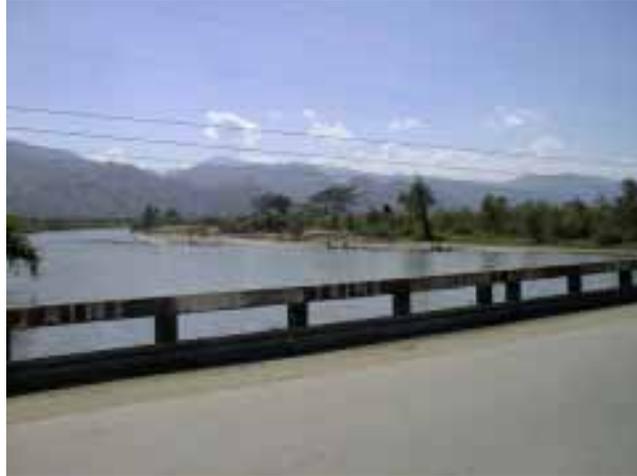
22. Bridge over Rio Tocoa (N15.64767, W86.01424) (see Photo 20). The bridge is in good condition but the streambed has risen because of heavy sedimentation, causing the freeboard to be reduced to less than 1 meter. The team recommends that a higher bridge, about 80 meters long, be built at an estimated cost of \$341,000 (U.S.) (priority 2).

Photo 20. *Heavy Stream Siltation has Raised Water to Hazardous Level*

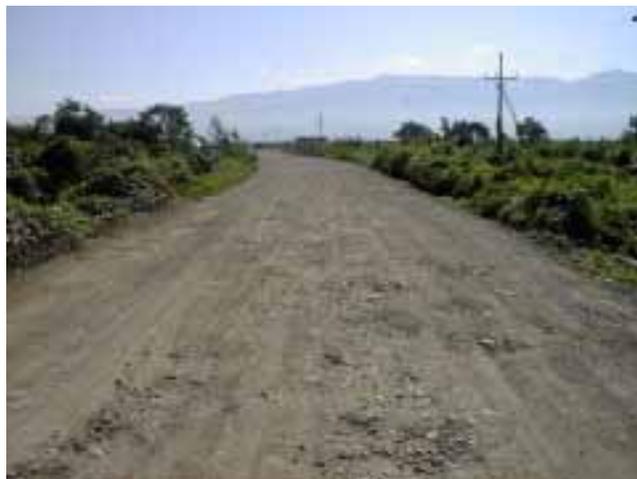
23. There is extensive alligator cracking in the section of roadway from the access to Trujillo to the Port of Castilla. The structural section of this pavement needs to be enhanced. The team recommends a thick overlay (3 to 4 inches) and improved drainage. The side ditches have been obstructed by heavy vegetation. Estimated cost is \$136,000 (U.S.) (Priority 2).

Photo 21. *Parallel Relief Road Should Be Paved*

23. Roadway access to Trujillo to Puerto Castilla—Extensive alligator cracking of roadway; side ditches obstructed by heavy vegetation; recommend thick pavement overlay (3 to 4 inches) and improvement to drainage	\$136,000
